STRUCTURES: GLADSTONE CONSERVATORY

A TOUCH OF GLASS

Engineers have meticulously dismantled and reassembled a listed Victorian glasshouse in Liverpool. **Jessica Rowson** reports from historic Stanley Park.

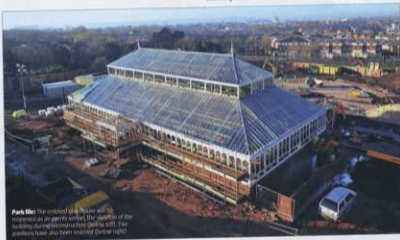
Watertight: Modern glazing will prevent rain leaking into the building

Instead the team is installing glazing in new leak-proof frames directly above its original locations, while retaining the original but empty frames inside. These new frames have modern seals and do not alter the existing structure or add significantly to loadings.
